**IN THE UNITED STATES DISTRICT COURT
FOR THE DISTRICT OF MINNESOTA**

**COMPLAINT AND DEMAND FOR JURY
TRIAL**

THE EXPLOSION OF JANUARY 11, 2017

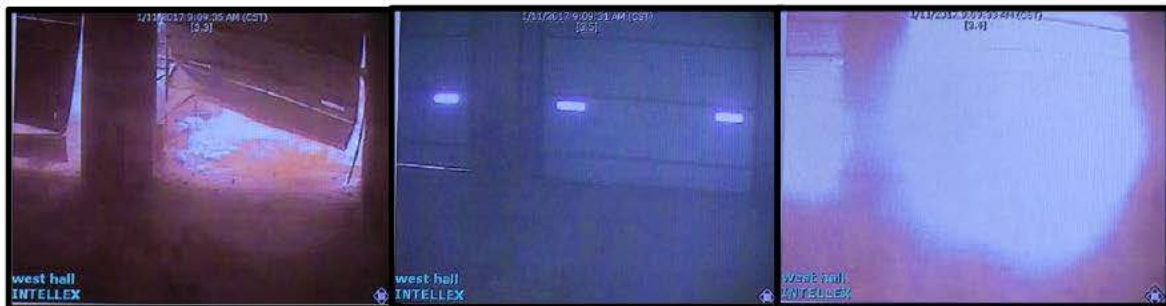
18. The force of the explosion is evident in the surveillance video from inside the building:

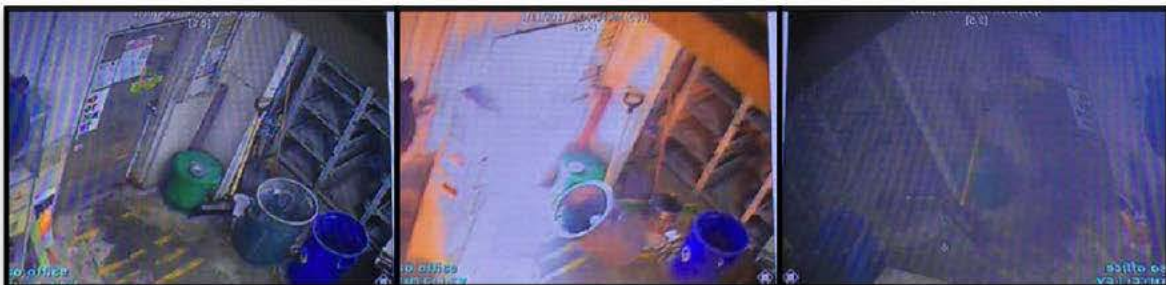
19. This portion of the surveillance video shows how quickly and completely the building filled with smoke following the explosion:

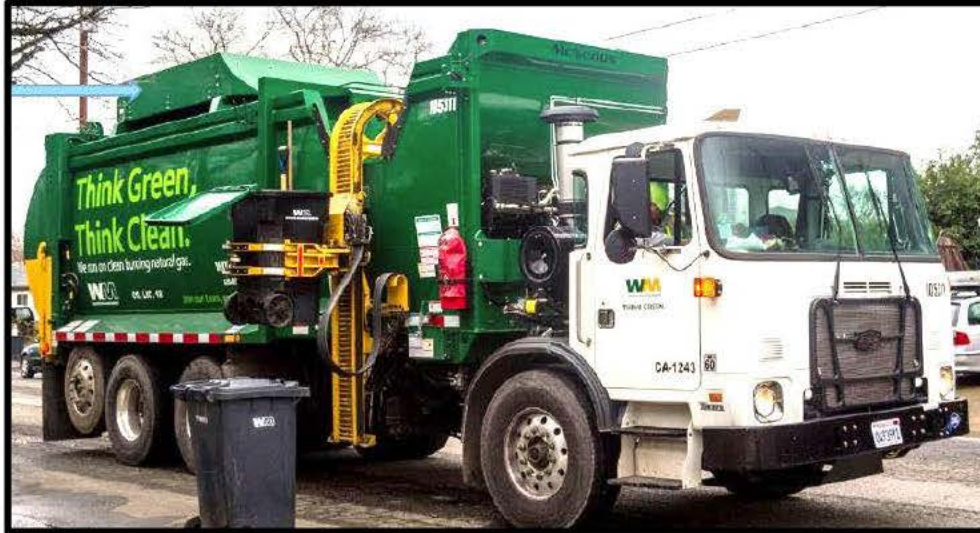
21. The CNG-powered refuse truck involved in the explosion (similar to the one shown below, utilizing a rear-loading system to lift trash into the vehicle) was being assembled by McNeilus for Waste Management, a national disposal and recycling company.

22. CNG-powered trucks do not have traditional gasoline engines, but instead run on compressed natural gas stored in pressurized cylinders atop the vehicle (in the area under the cowling marked by the blue arrow in the above photo). The CNG fuel system transfers the high-pressure natural gas from the fuel tanks to the engine.

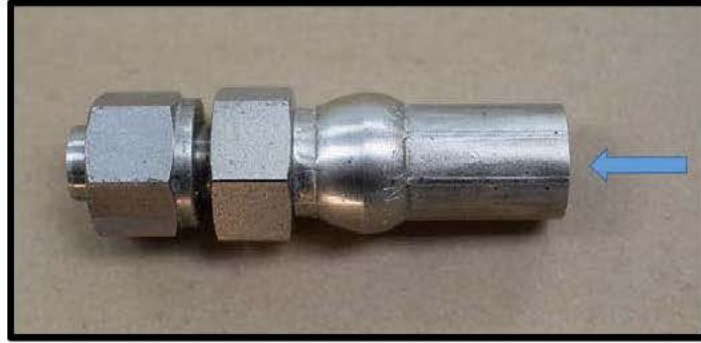
28. The image below depicts the fitting manufactured by Swagelok which attached to the hose that separated from the subject truck's CNG module on January 11, 2017, resulting in the release of pressurized natural gas that caused the explosion.

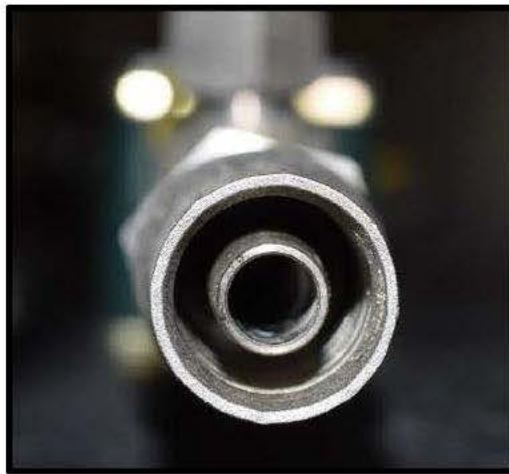
29. The image below shows the interior of the Swagelok fitting (viewed from the vantage point of the right side of the above-pictured fitting) involved in the explosion.

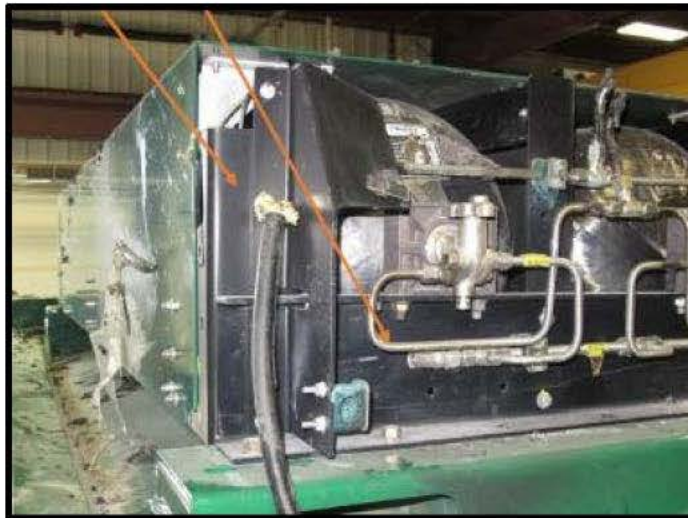
34. The image below of the subject refuse truck taken after the January 11, 2017 explosion shows the remnants of this failure mode: the hose end identified by the left-most orange arrow blew off the fitting identified by the right most arrow:

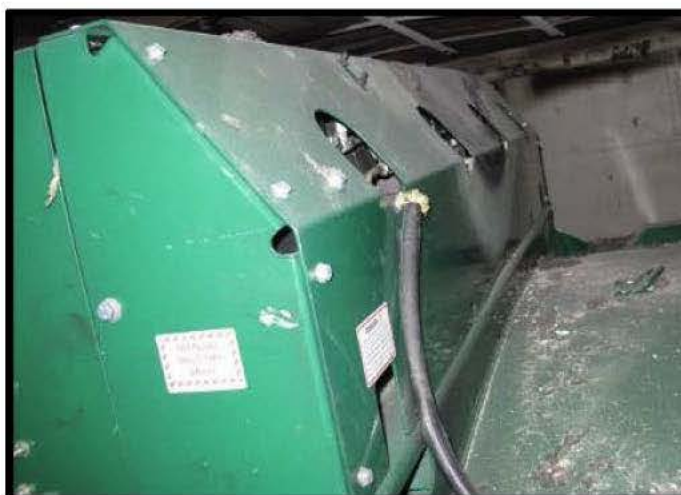
35. The above view shows the truck with the cowling cover removed; the image below shows the hose separation before removal of the cowling cover:

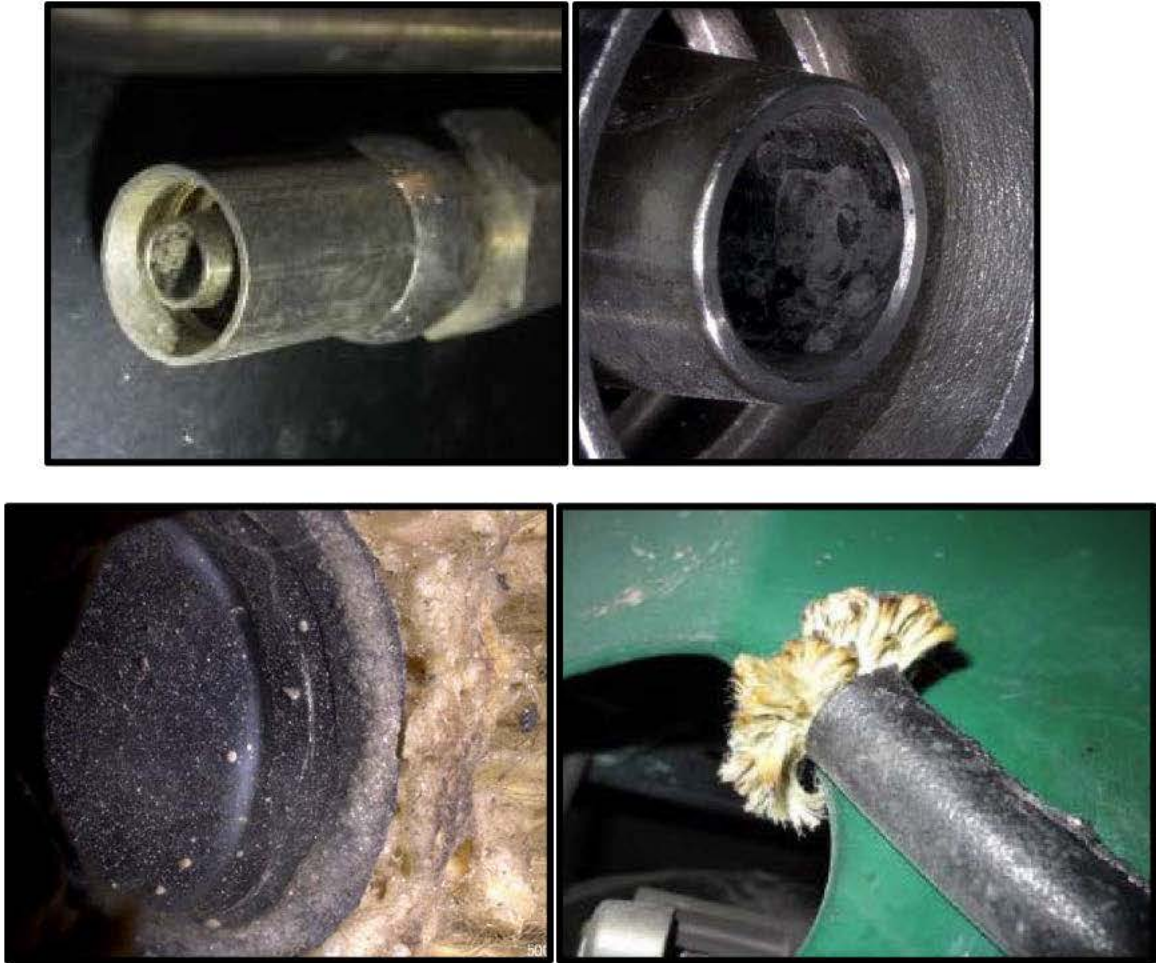
36. Close-ups of the hose and fitting ends can be seen in the photographs below. Technical analysis confirmed the lack of engagement of the hose assembly due to Defendant Swagelok's failure to fully engage and seat the hose within the fitting prior to compression:

37. As shown in the above photographs taken after the explosion, the “failed” end of the hose reveals a complete dislodgement of the hose from the crimp connection of the metallic fitting end (interior view of the hose end, at left; note the only two circumferential ring indentations from the proximal end of the barb tip).

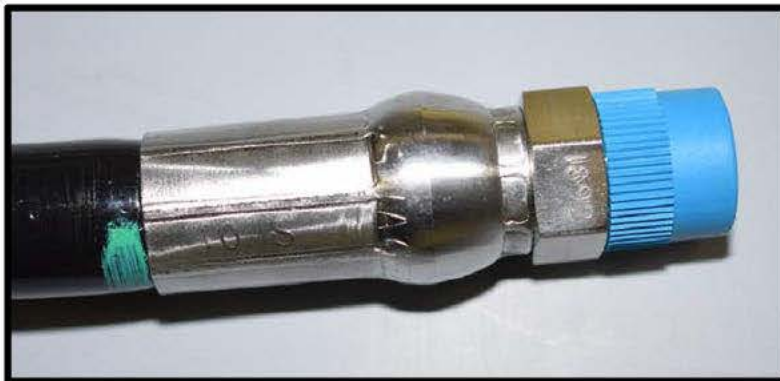
40. In fact, if Swagelok actually did what it claimed to do, the failure to properly seat the hose would have been easily detected and would have prevented the January 11, 2017 explosion and the catastrophic injuries suffered by Eemou See. Among other reasons, a properly assembled hose has a simple marking – which should be made before the hose is inserted on and into the fitting – showing the proper insertion depth.

41. In the photograph above of an exemplar Swagelok hose assembly, the green marking on the fabrication just outside the metal fitting was made to ensure that the hose was fully inserted into the coupling prior to compression of the metal coupling onto the hose. The Swagelok hose assembly which failed on January 11, 2017 lacked such a marking to ensure proper insertion depth. As a result, the subject hose was not fully inserted into the metal fitting and there was not enough clamping length to securely connect the hose to the fitting.
